**ECOHYDROLOGICAL PERSPECTIVES OF DEGRADING BAOLIS DURING  
MEDIEVAL PERIOD IN DELHI: traditional practices of water management**

**Ecohydrological perspectives of degrading Baolis during Medieval Period in Delhi:  
traditional practices of water management  
Subhash Anand; Pankaj; Harish Kumar**

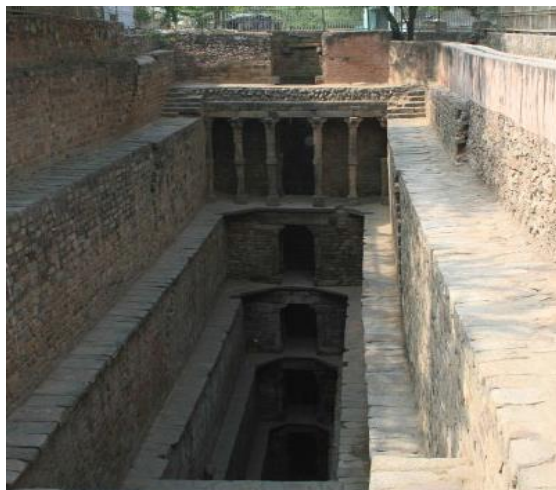
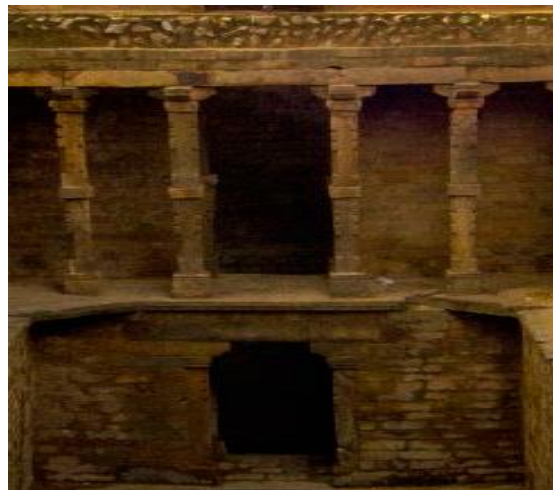
Figure 5 – a. Five floors of Gandhak ki *Baoli*.  
Source: Primary survey.

b. Top two floor of Gandhak ki *Baoli*.

The Figure 5a. represents the five floors of these *Baoli* and Figure 5b. represents the top two floor of this *Baoli* which are showing the spot of seepage on the walls of this *Baoli*. The last floor has some amount of water but that is covered by algae.

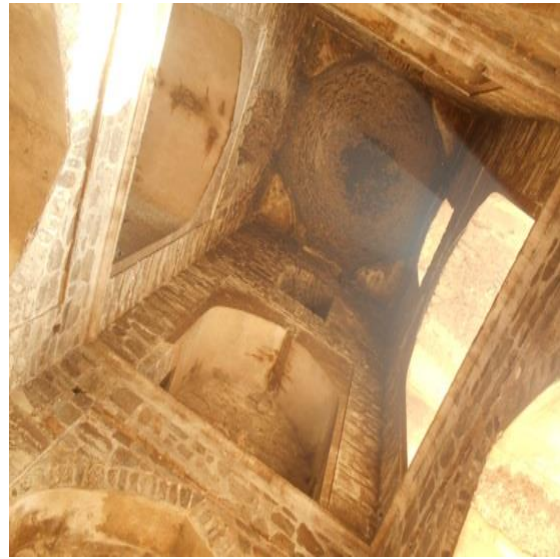
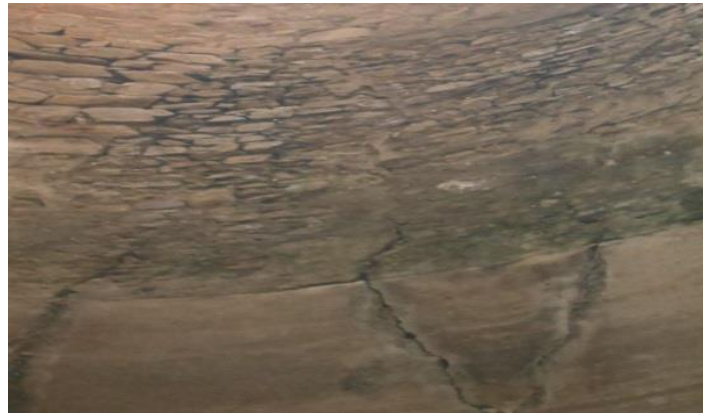
Figure 6 – a. Dried steps of Agrasen ki *Baoli*

b. Roof covered with bats of Agrasen ki *Baoli*

c. The Destroyed wall of well at Agrasen ki *Baoli*

Figure 6a. represents the dried condition of *Baoli* and people are treating it as tourist place and Figure 6b. represents condition of roof of this *Baoli* that is covered by the bats and the Figure 6c. represents the condition of destroyed wall of it well that is almost 150-160 feet. The wall of well is also covered with algae and some patches of seepage can be seen.

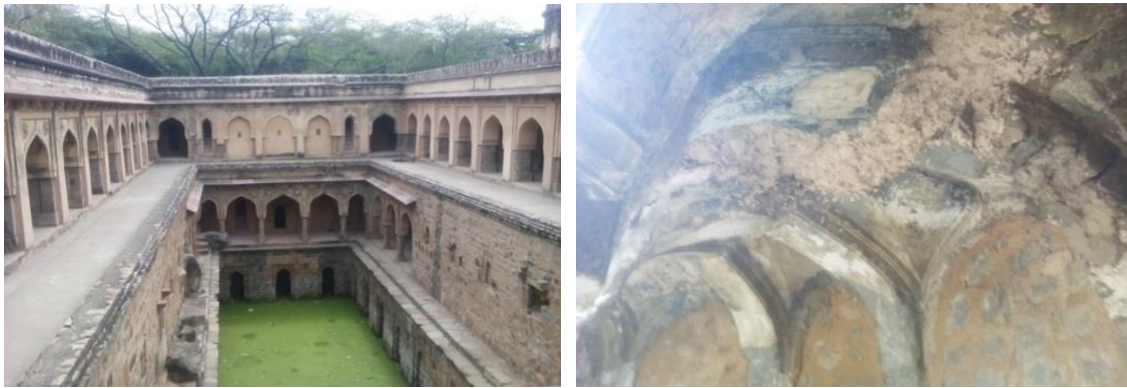
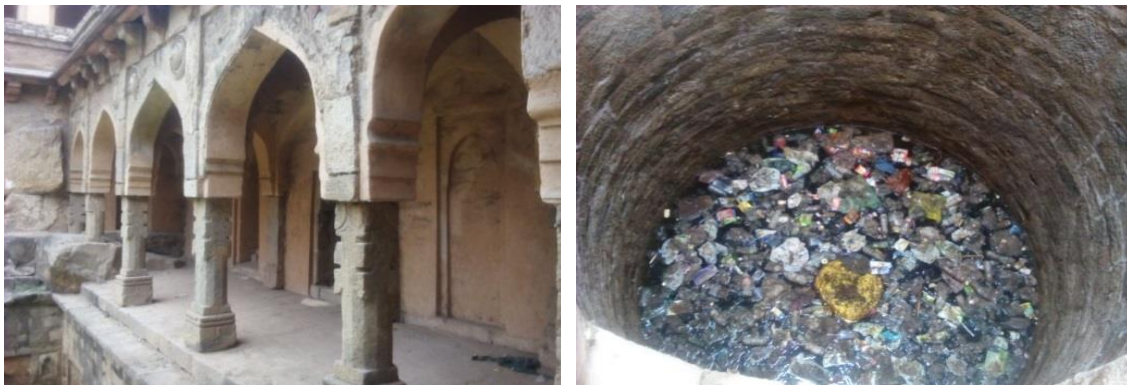
Figure 7 – a. Water covered with algae at Rajon ki Baoli b. renovated roof at Rajon ki Baoli

c. Square and round Pillars at Rajon ki Baoli

d. Polluted well at Rajon ki Baoli

This *Baoli* is located in Mehrauli and it is not used by the people of local community and ASI as well. The Figure 7a. represents the conditions of water that is very much polluted and it is covered with very thick algae. This comprises five floors and each floor has been restored by ASI because most part of this *Baoli* was ruined. The Figure 7b. represents the top floor that has been restored in its previous form and shape but not in proper way and other floors were also not restored properly and most of the sections of this *Baoli* are not restored and those required restoration. The Figure 7c. represents the square pillars of this *Baoli* and the last Figure 7d. represents the polluted well of this *Baoli*.

The surface of water in the well is covered with solid waste pollutant. The stairs that goes to roof are also required some consensus.

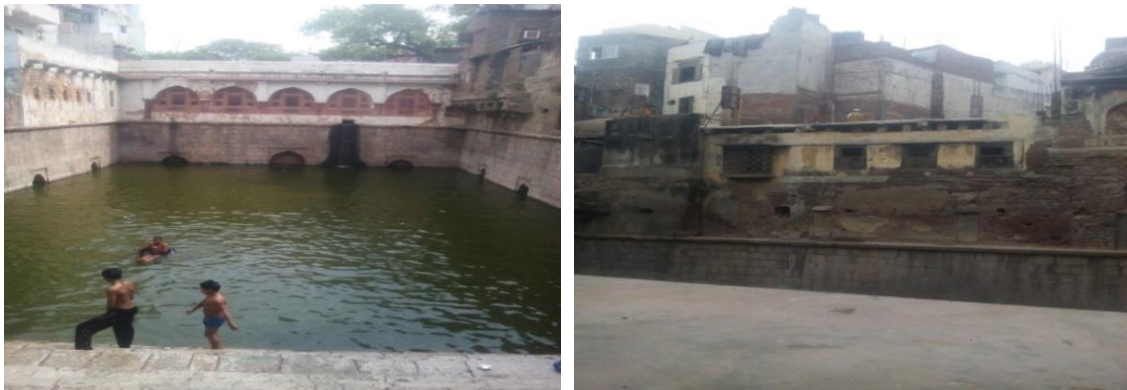
Figure 8 – a. Children's bathing in Nizamuddin ki *Baoli* b. Ruined walls of Nizamuddin ki *Baoli*  
Source: Primary survey.

The Figure 8a. represents the condition of *Baoli* of Nizamuddin where children's are bathing and another Figure 8b. represents the conditions of wall of this *Baoli*. The wall of this *Baoli* is almost degraded. This is concerned as sacred place for one community therefore it is still in use. This *Baoli* has lost their infrastructure and new encroachment taken place. This *Baoli*'s area was occupied by local people. Water is polluted and people do not recognize the importance of this *Baoli* except the sacred importance.

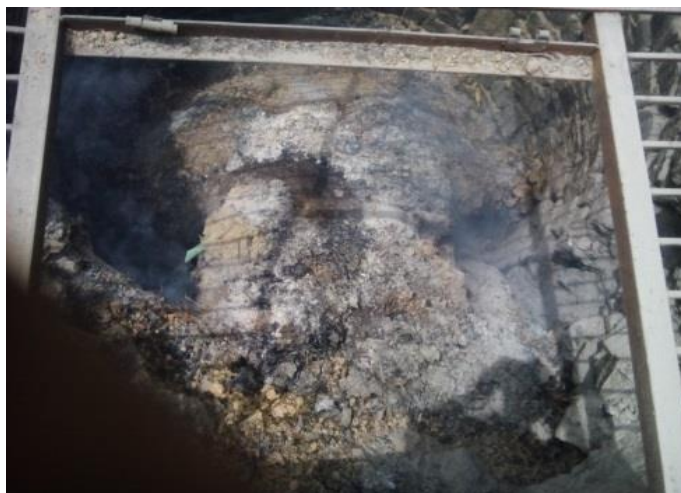
The well of Kutub Shah ki *baoli* that is degraded and full of dust and waste. This well is being used by the local community as waste disposal center (Figure 9).

Figure 9 – Dried and extinct well of Kutub ki *Baoli*  
Source: Primary survey.

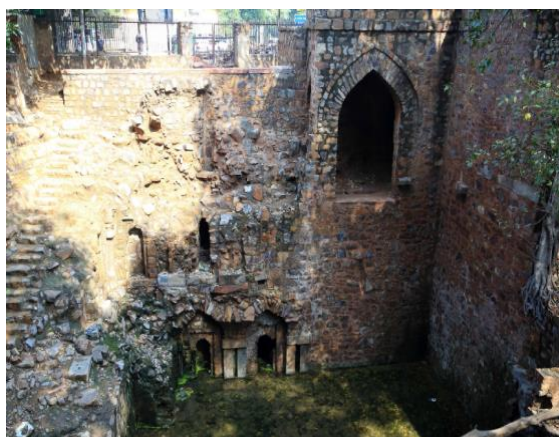
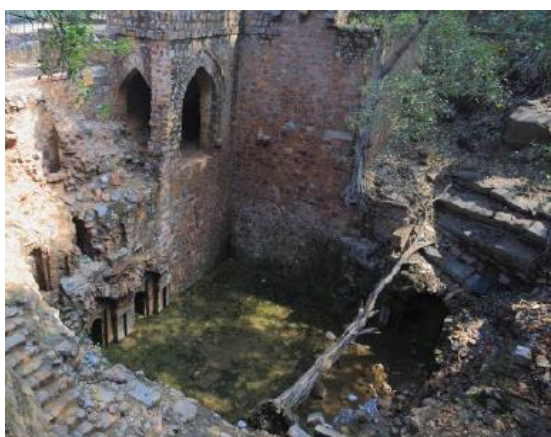
Figure 10 – a. ruined stairs of Hindu Rao ki *Baoli*  
Source: Primary survey

b. ruined structure of Hindu Rao ki *Baoli*

The Figure 10a. represents the destroyed stairs of this *Baoli* because these stairs are almost eroded or degraded and Figure 10b. represents the ruined structure of its cabins and walls.
